JUNE 1978

**NASA Technical Paper 1210**

# **Light Airplane Crash Tests at Three Flight-Path Angles**

**Claude B. Castle and Emilio Alfaro-Bou**  
*Langley Research Center*  
*Hampton, Virginia*

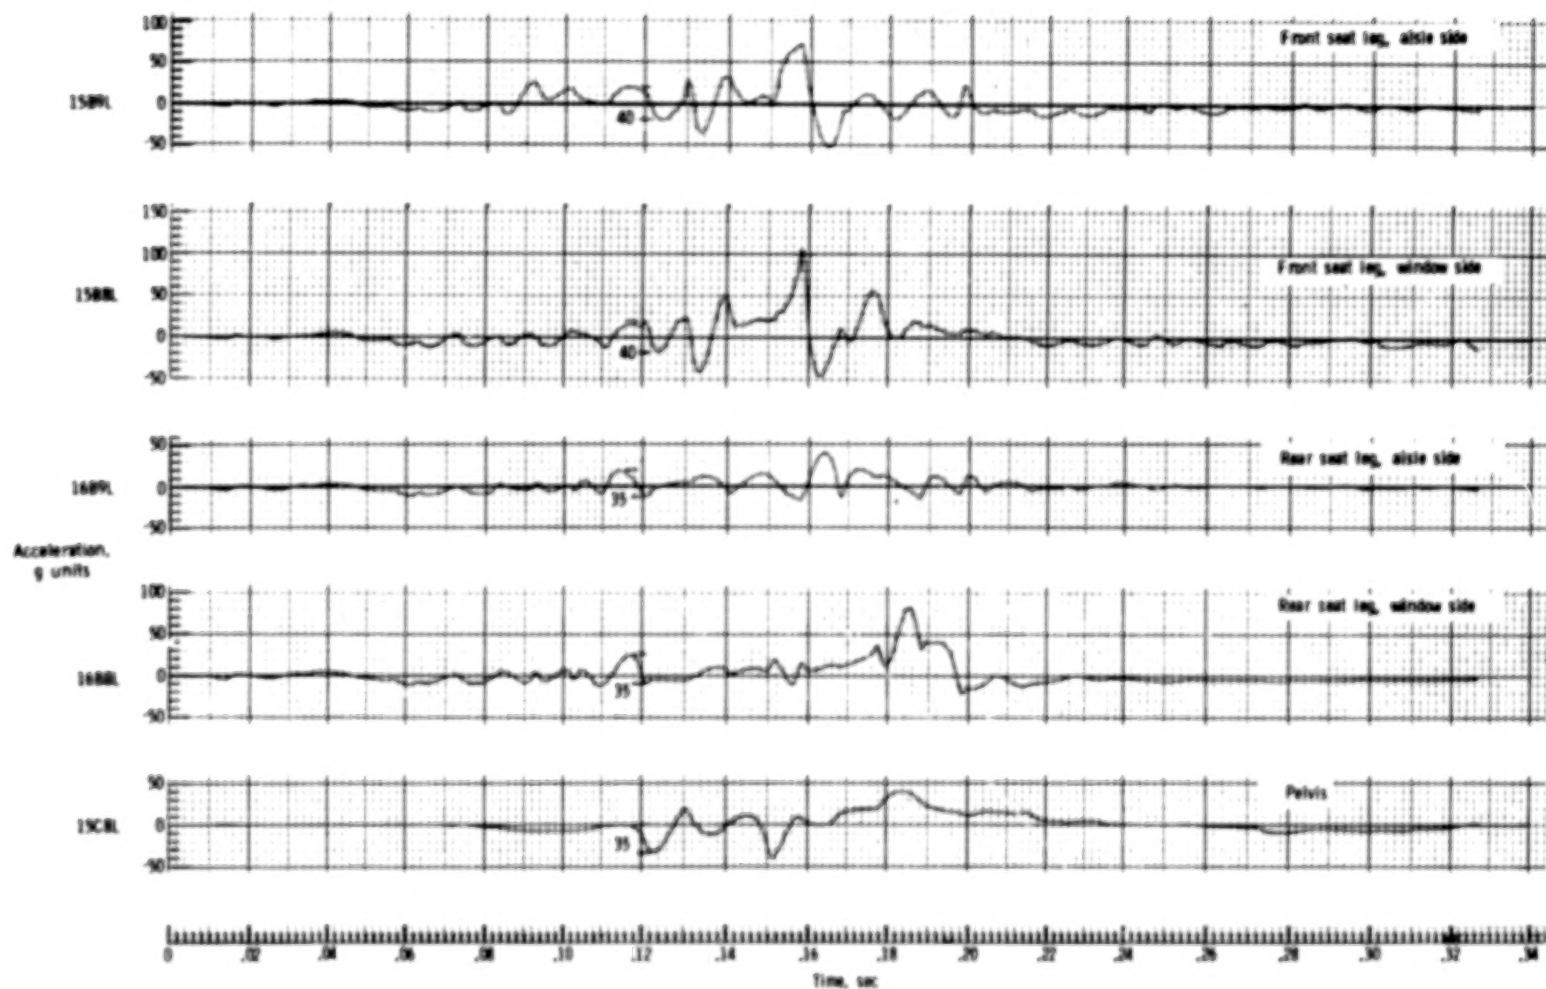
Figure 22.- Concluded.

Longitudinal accelerations at  $-45^\circ$ . - As shown for the  $-45^\circ$  test specimen in figure 22(c), longitudinal peak-to-peak accelerations adjacent to each of the four seat legs were approximately the same: 40g for the two front legs and 35g for the two rear seat legs. The pelvis also experienced the same value as the two rear legs of 35g occurring 0.025 sec later.
